PLX TECHNOLOGY INC

RELIABILITY REPORT

DEVICE PART NUMBER: PCI9056-BA66BI G (Pb-Free)

PACKAGE TYPE: 256 PBGA

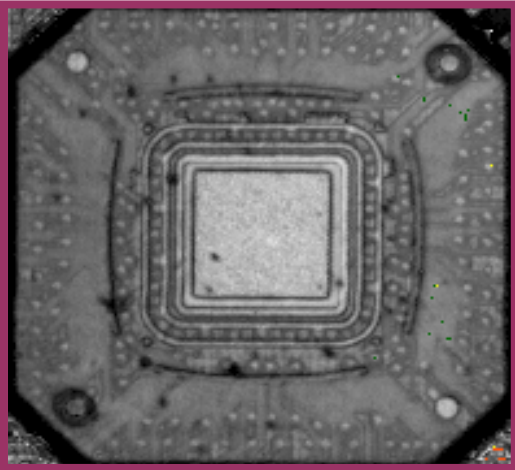
FIGURE 1a: TOP SCAN IMAGE SHOWS NO DELAMINATION AT INITIAL STAGE

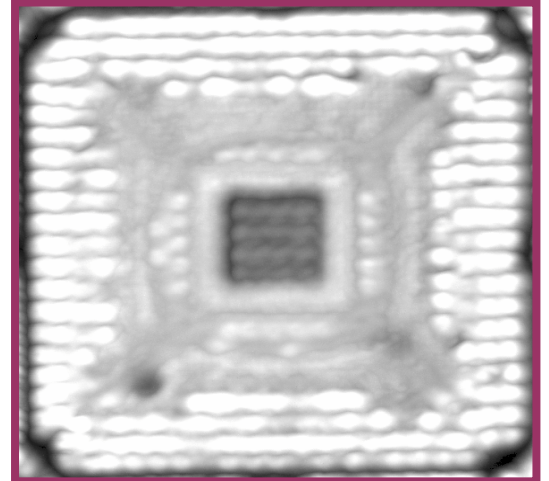
FIGURE 1a: THRU SCAN IMAGE SHOWS NO DELAMINATION AT INITIAL STAGE

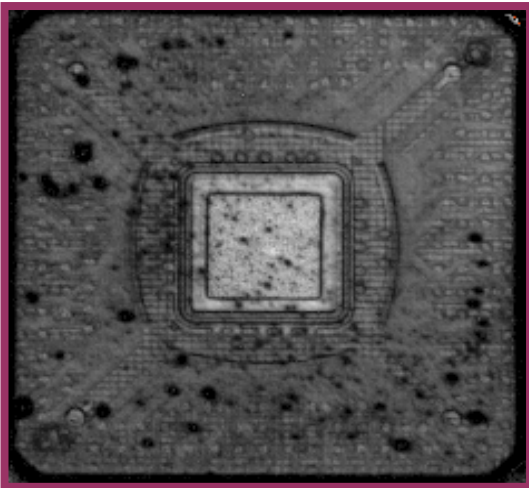
FIGURE 1b: NO DELAMINATION NOTED ON TOP SCAN AFTER MSL 3 CR@260°Cx3 (0/45 UNITS )

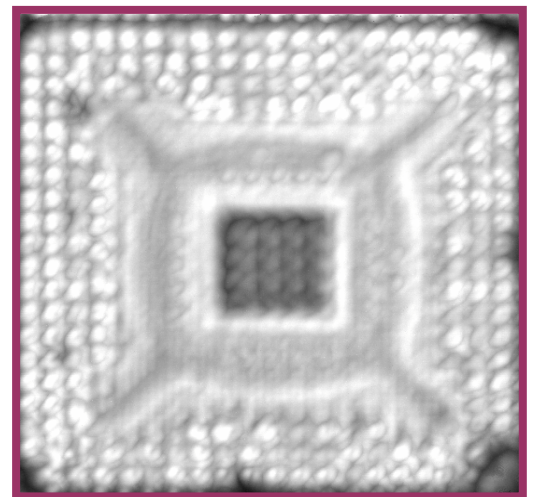
FIGURE 1b: NO DELAMINATION NOTED ON THRU SCAN AFTER MSL 3 CR@260°Cx3 (0/45 UNITS )

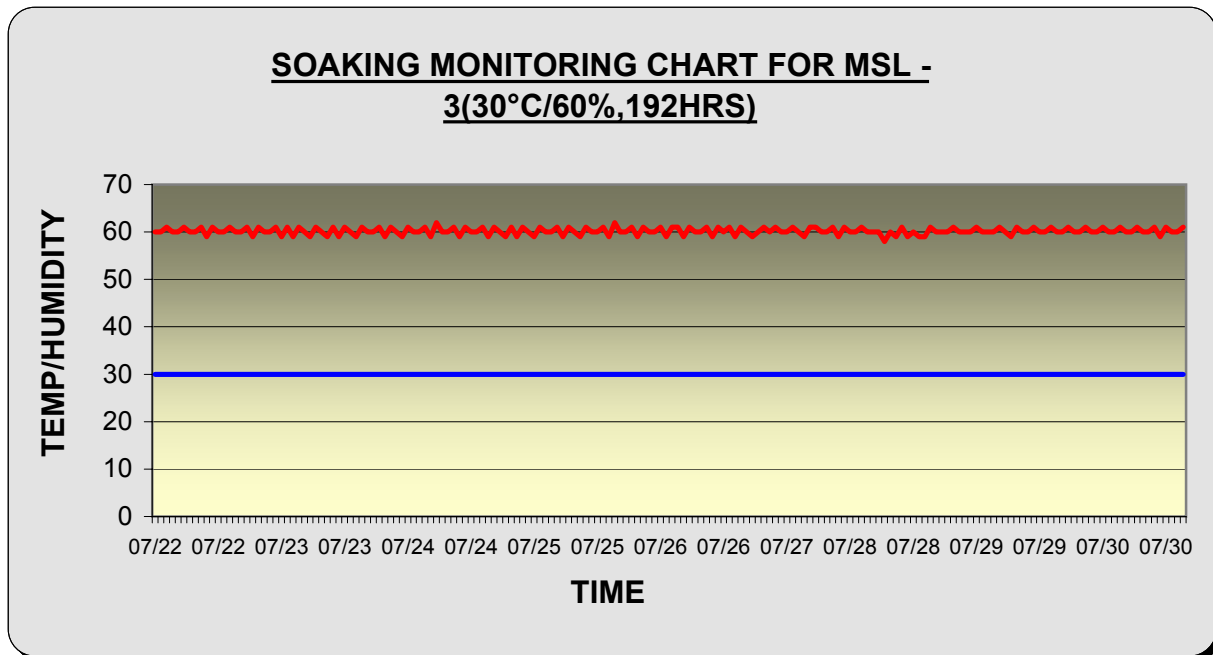
### 8.1 PRECOND LEVEL 3 SOAKING MONITORING CHART @ 30°C/60%RH,192HRS

No significant abnormalities noted during moisture soaking 30/60 except few interruption due loading/unloading.
